Revision Guide for AMD Family 10h Processors

Publication # **41322** Revision: **3.16**
Issue Date: **February 2008**

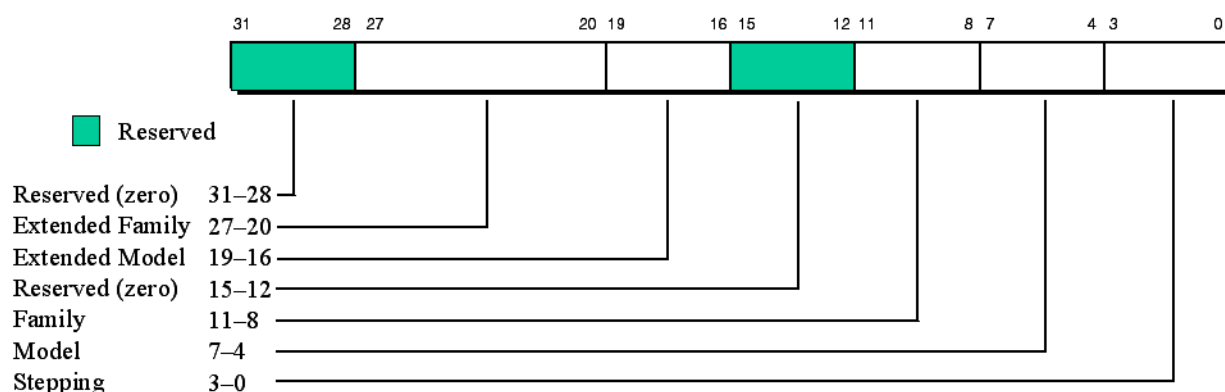
Figure 1 shows the format of the value returned in EAX by CPUID Function 1.

Figure 1. Format of CPUID Value Returned by Function 1
