# Brocade Fabric OS v5.0.3 GA Release Notes v1.0

December 23, 2005

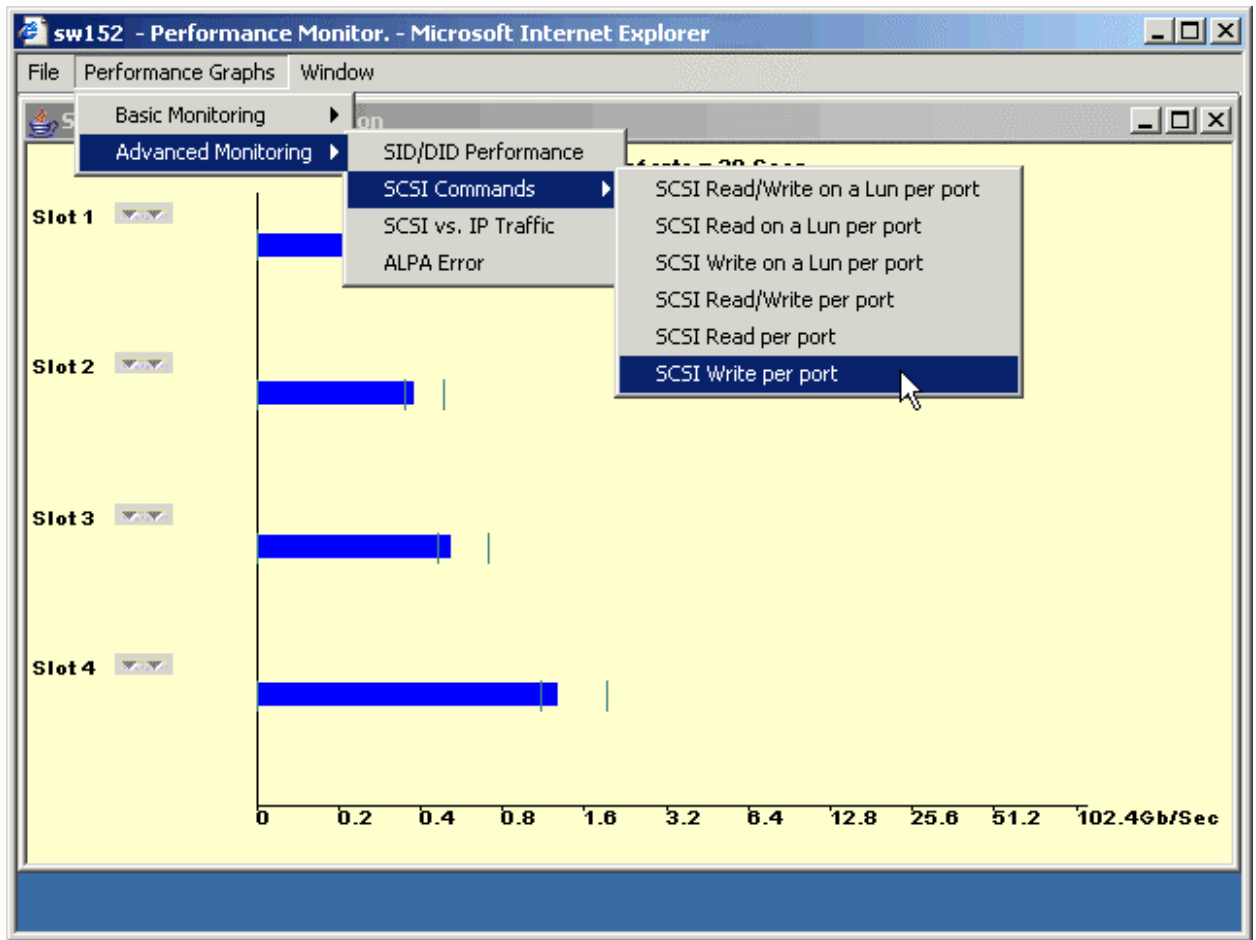
**Figure 14-1** Accessing Performance Graphs

Port throughput utilization is represented by a horizontal bar for each selected port, which gets longer or shorter depending on the percent utilization for that port at the last poll time. Thin short vertical intersecting bars give a historical perspective by representing the highest and lowest values reached for each selected port since the graph was opened. A third bar between them represents the average of all values polled. (See Figure 14-1.)

On page 14-3, replace Figure 14-1 with this one:
